Development of Weld Inspection of the Ares I Crew Launch Vehicle Upper Stage

Sam S. Russell
Nondestructive Evaluation Team
NASA Marshall Space Flight Center
(256) 544-4411
Sam.Russell@NASA.gov

NASA is designing a new crewed launch vehicle called Ares I to replace the Space Shuttle after its scheduled retirement in 2010. This new launch vehicle will build on the Shuttle technology in many ways including using a first stage based upon the Space Shuttle Solid Rocket Booster, advanced aluminum alloys for the second stage tanks, and friction stir welding to assemble the second stage. Friction stir welding uses a spinning pin that is inserted in the joint between two panels that are to be welded. The pin mechanically mixes the metal together below the melting temperature to form the weld. Friction stir welding allows high strength joints in metals that would otherwise lose much of their strength as they are melted during the fusion welding process. One significant change from the Space Shuttle that impacts NDE is the implementation of self-reacting friction stir welding for non-linear welds on the primary metallic structure. The self-reacting technique differs from the conventional tec

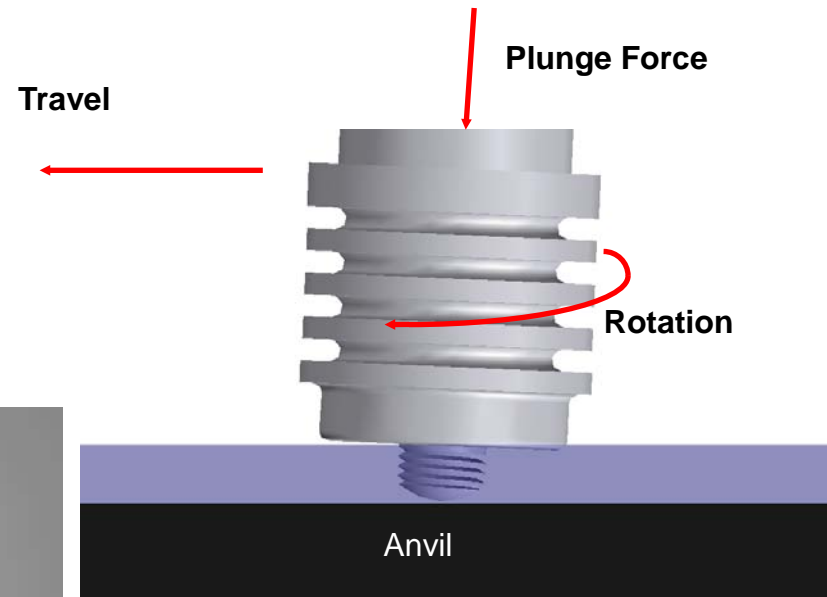
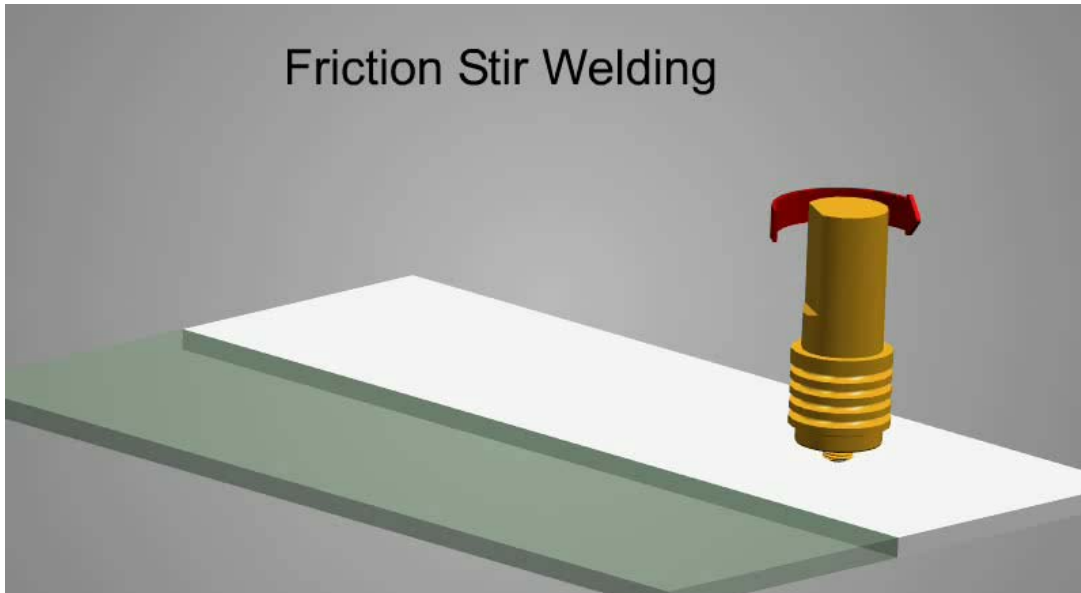
Conventional Friction Stir Welding (FSW)

- Solid State Process
- Uses Non-Consumable Rotating Tool
- Rotating tool is plunged into work piece until the tool shoulder is in contact with the work piece. Tool then traverses along the weld joint. At end of weld joint the tool is withdrawn from the work piece.

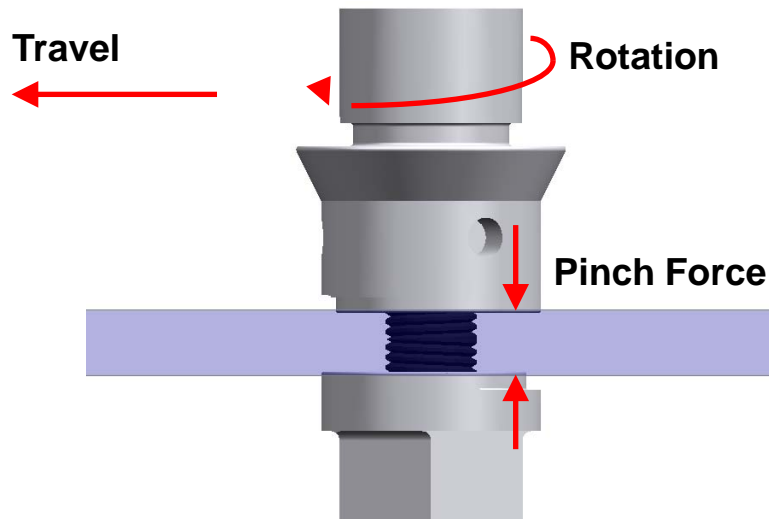
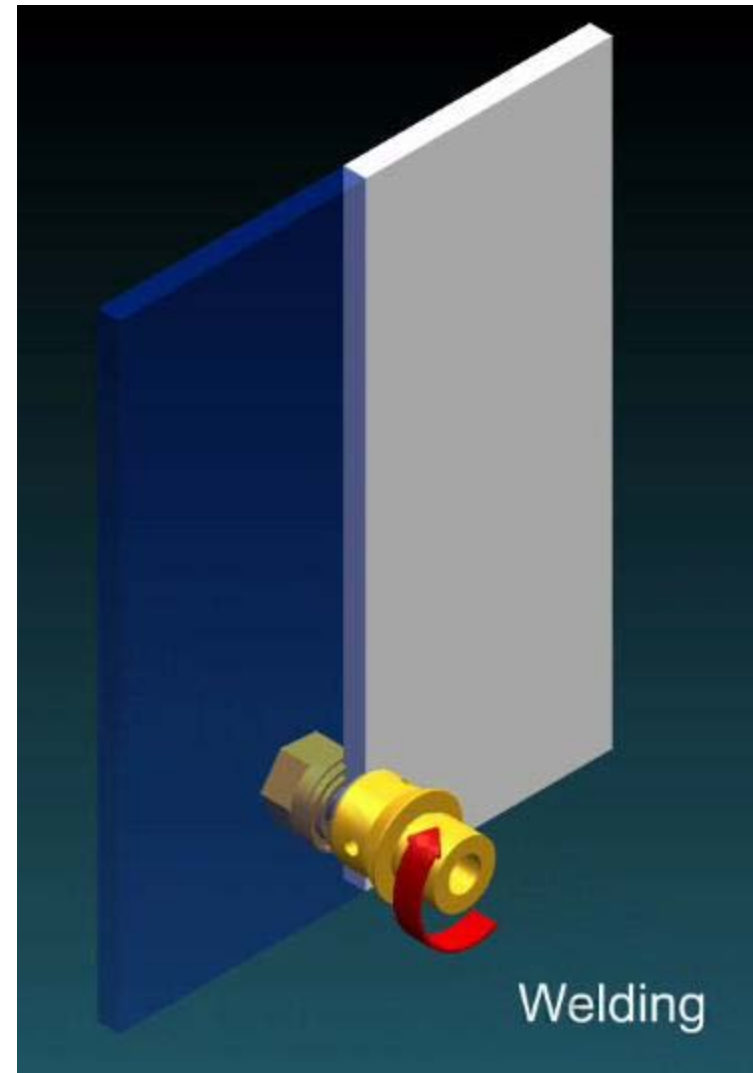
Self Reacting Friction Stir Welding (SR-FSW)

- No Anvil Required
- Rotating tool “pinches” the work piece between two shoulders and traverses along the weld joint.

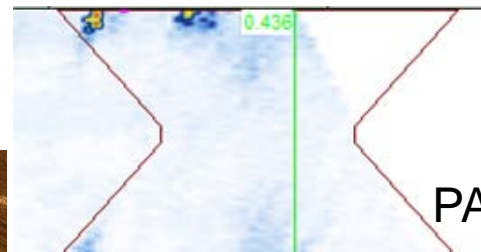
PAUT Data of Galling

Galling

Galling – tears on the surface of the weld visually indicated by open surface features, or blisters. – curvilinear discontinuities that occur at an angle to the surface on the advancing side of the weld. Subsurface tearing has only been noted in self-reacting welds in 2195. Subsurface tearing can occur below the root or crown surface, typically follow the grain boundaries and are very tight.

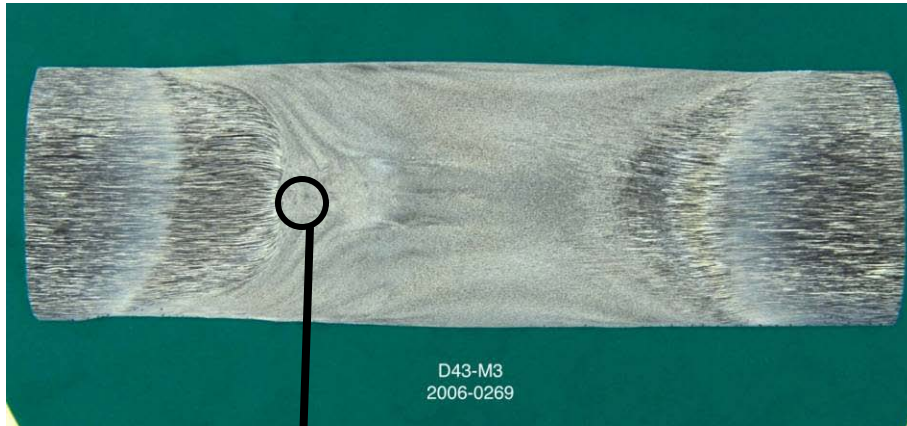
Defect Examples

Void

Wormhole/Voids/Lack of Adequate Forging – occur near mid-thickness on the advancing side close to the thermo-mechanical zone boundary and appear as voids, void clusters and linear defects. These defects may be three dimensional and traverse in the direction of the weld for some distance.

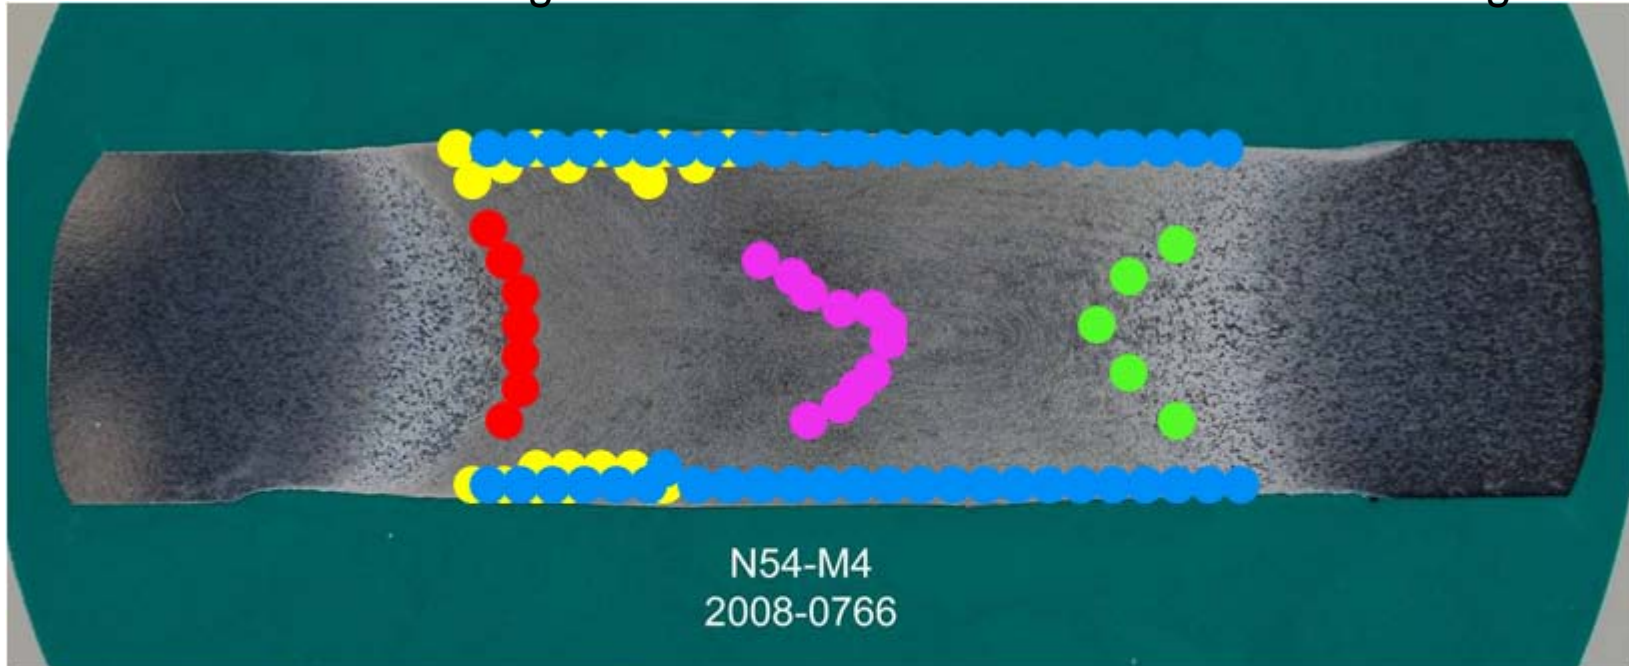
Typical Locations of Various Defects (SR-FSW)

- Wormhole
- Hot tears
- Galling
- Copper (bi-metallic)
- Start/Stop

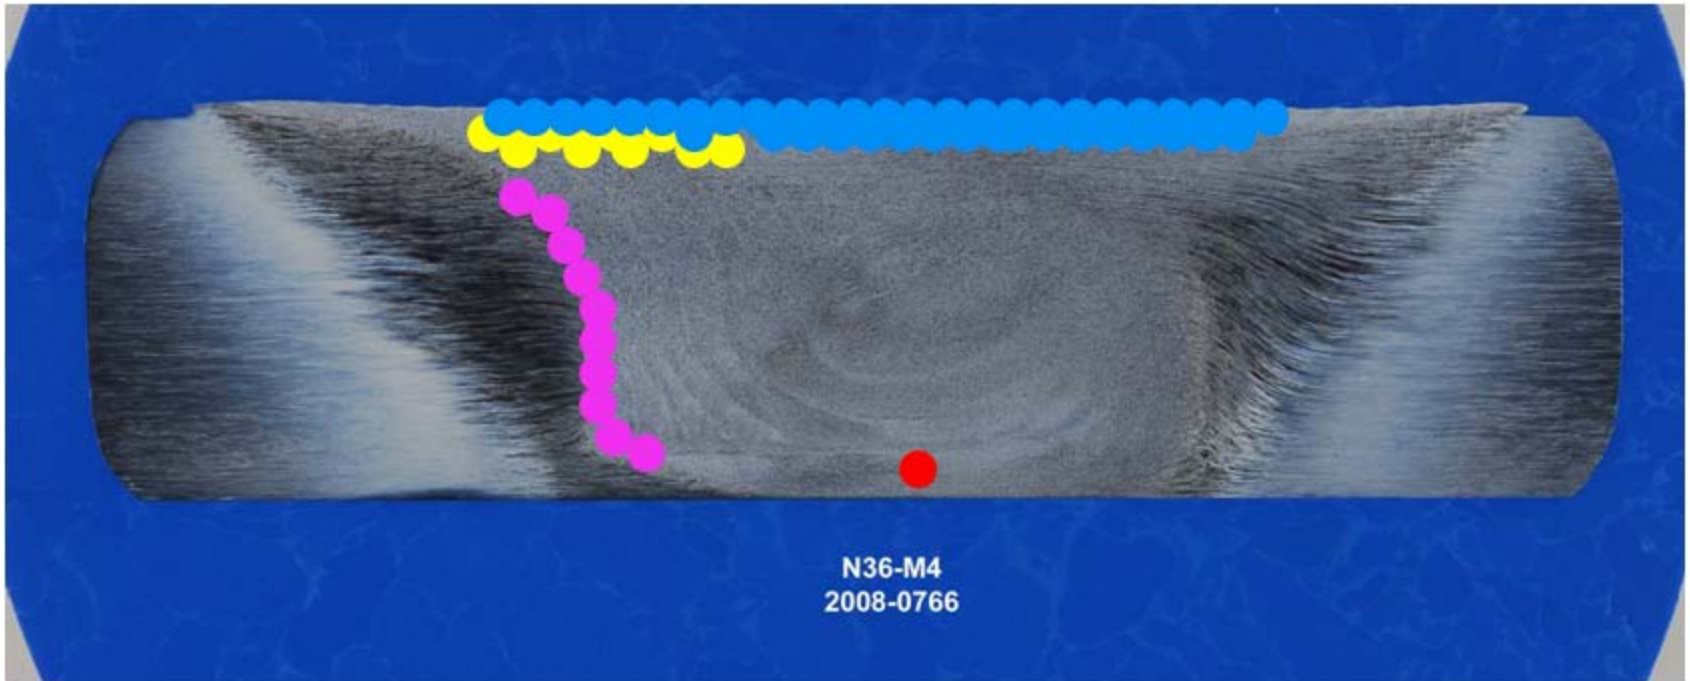
Typical Locations of Defects or Indications (C-FSW)

● Hot tears

● Lack-Of-Adequate Forging

● Galling

● Lack-Of-Penetration

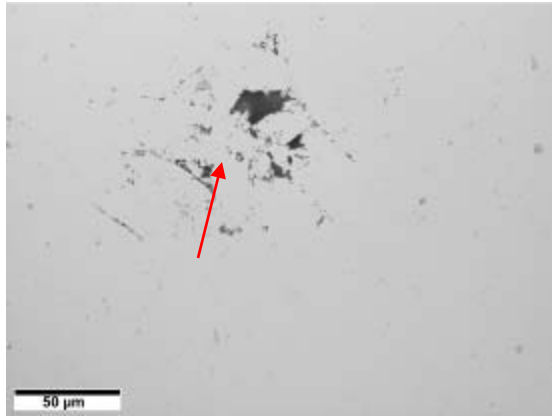
Photomicrograph showing wormhole in weld nugget

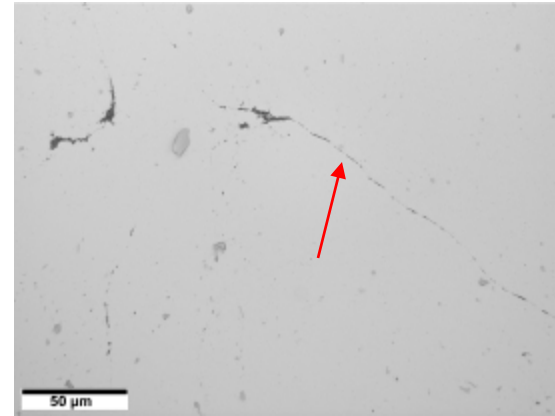
Photomicrograph that shows linear Indications in weld nugget

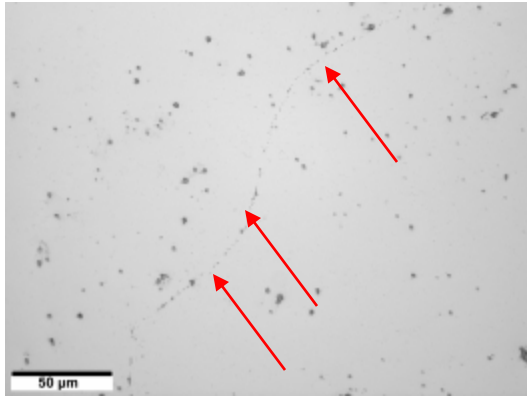
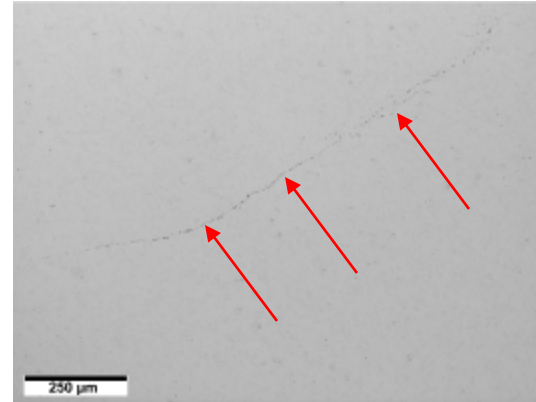
Residual Oxide Discontinuity - appears as a curvilinear oxide deposit running through the weld nugget. Residual oxide discontinuity (ROD) occurs in self-reacting friction stir welds.

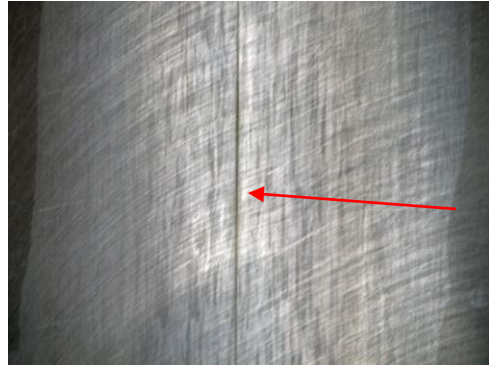
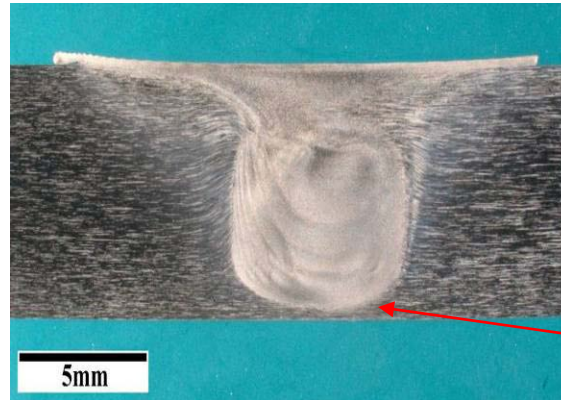
Lack of
Penetration in
Conventional
FSW

Lack of Penetration – an area of unconsumed weld joint, typically open to the surface, found on the root side of conventional friction stir welds

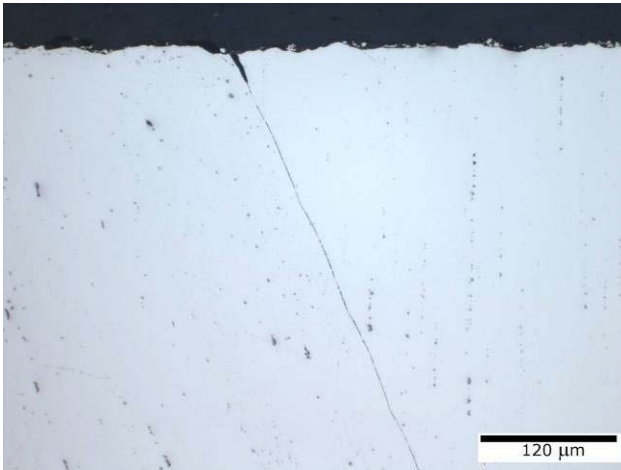
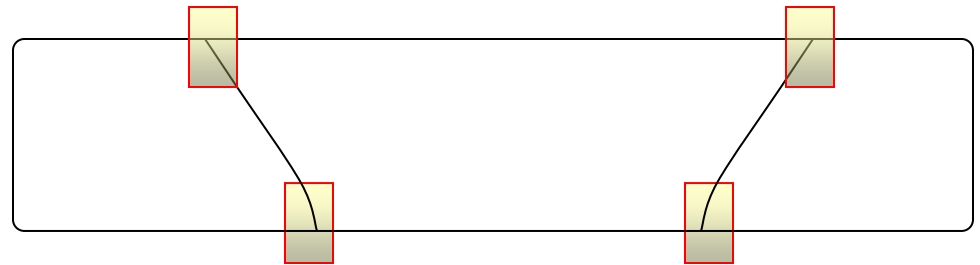
Typical locations of where disbonds occur in a FSW plug weld

Lack of Bonding – “kissing bond” at the interface between a friction stir plug weld and the surrounding material, usually near surface.
